# MEMORANDUM

**Re:** MD 28 Champion Tree Health Assessment Memorandum  
Contract 2007-17F Task 21 (FMIS # – PCA – 23843)

**MD 28 CHAMPION TREE ASSESSMENT  
FIELD SURVEY - DARNESTOWN, MD  
OCTOBER 14th, 2015**

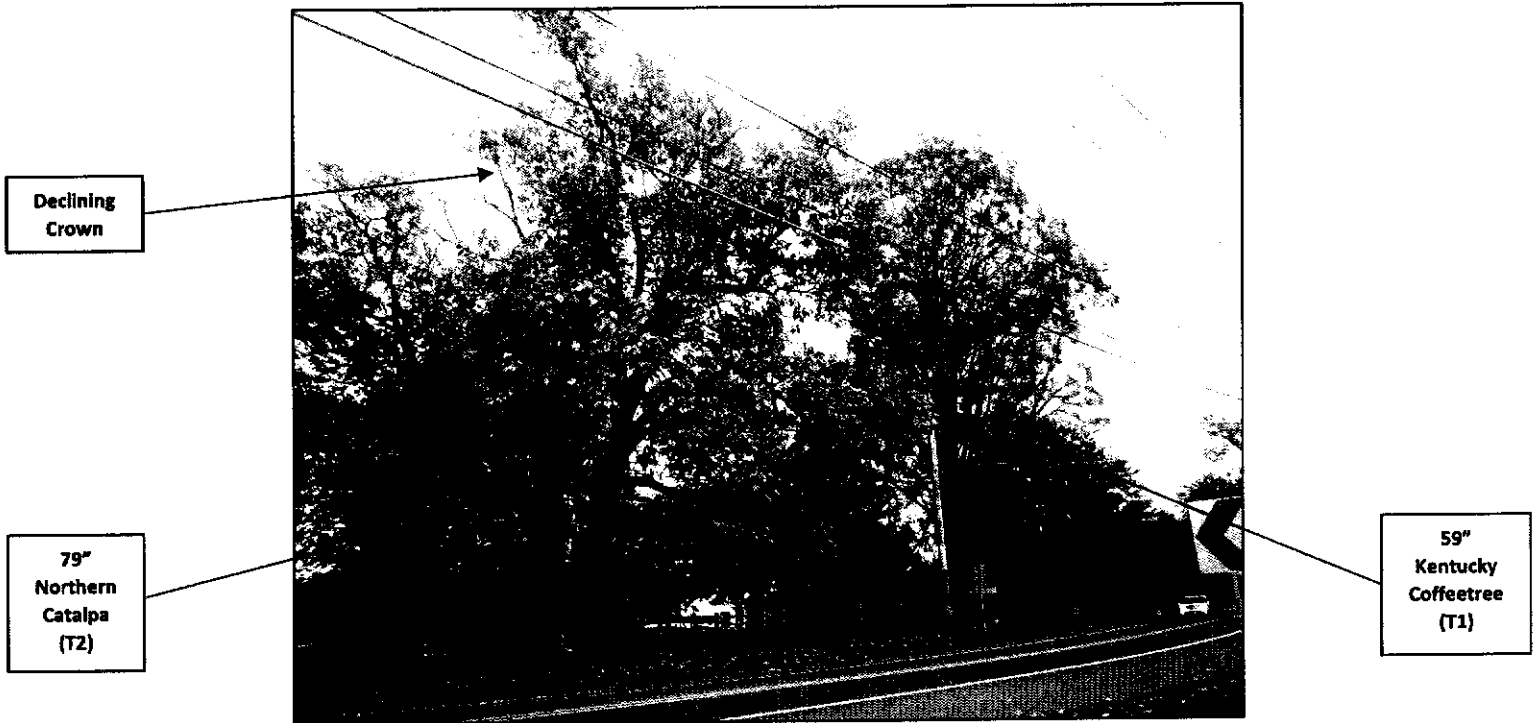
Photo 1. Facing northeast along Darnestown Rd. towards 59" Kentucky coffeetree (T1) and 79" northern catalpa tree (T2).

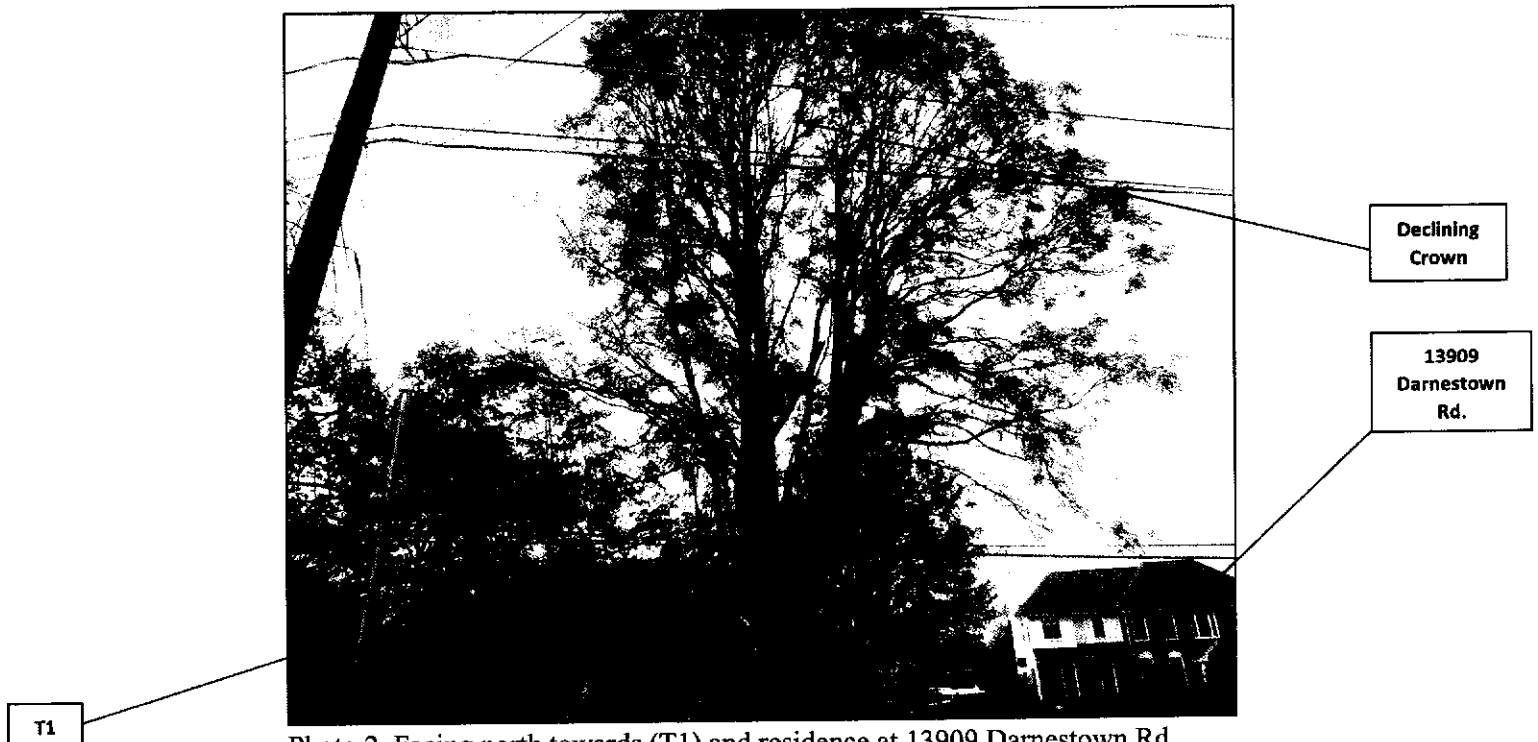
Photo 2. Facing north towards (T1) and residence at 13909 Darnestown Rd.

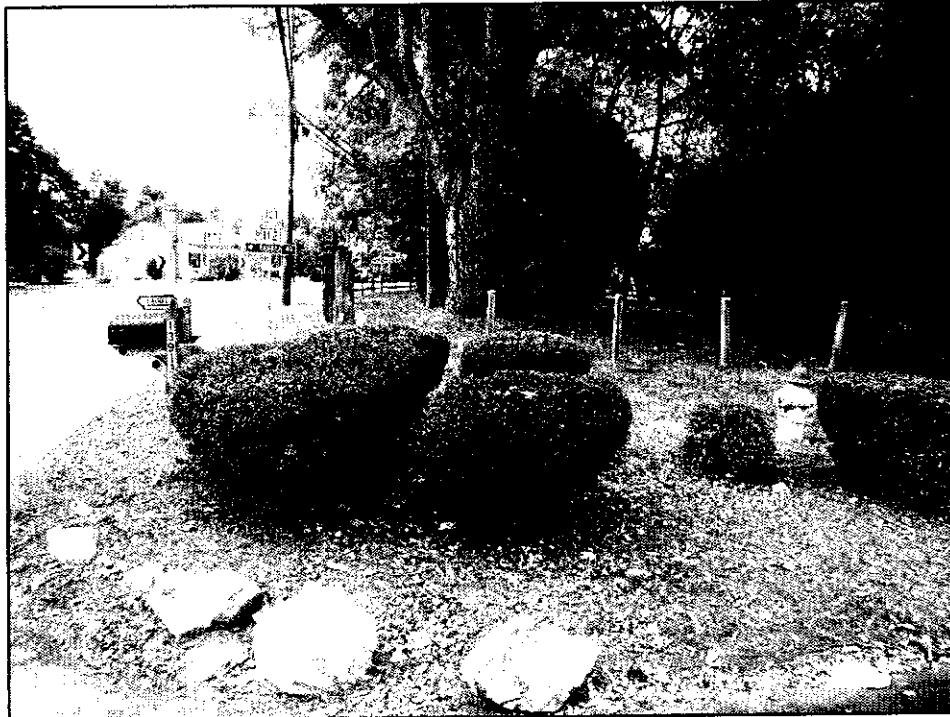
Photo 3. Facing west along Darnestown Rd. towards T1.

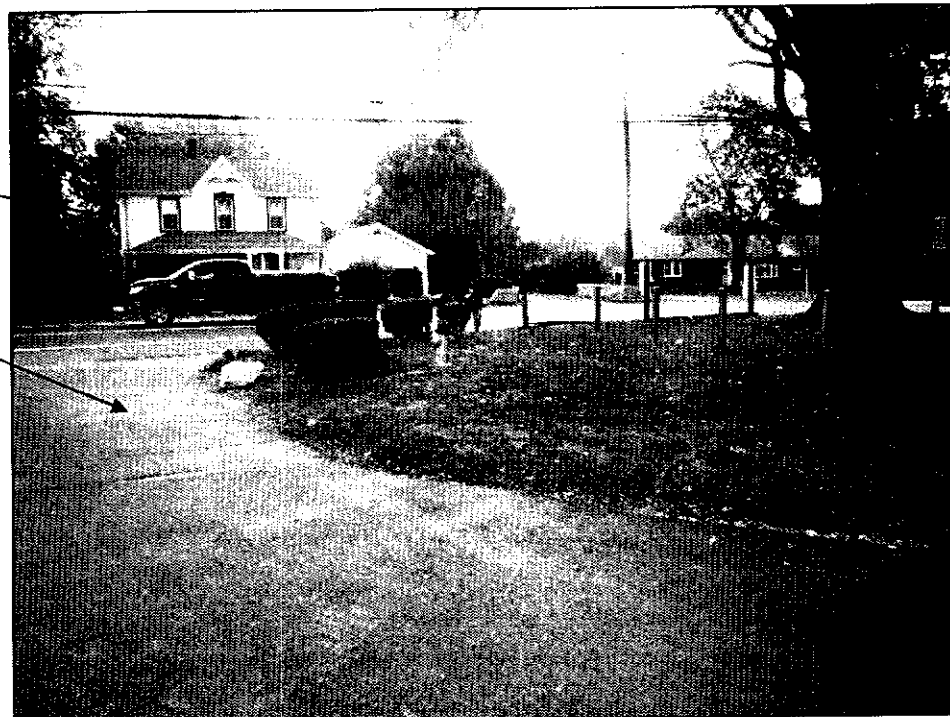
Photo 4. Facing south towards residence at 13920 Darnestown Rd. and school bus stop for neighborhood children

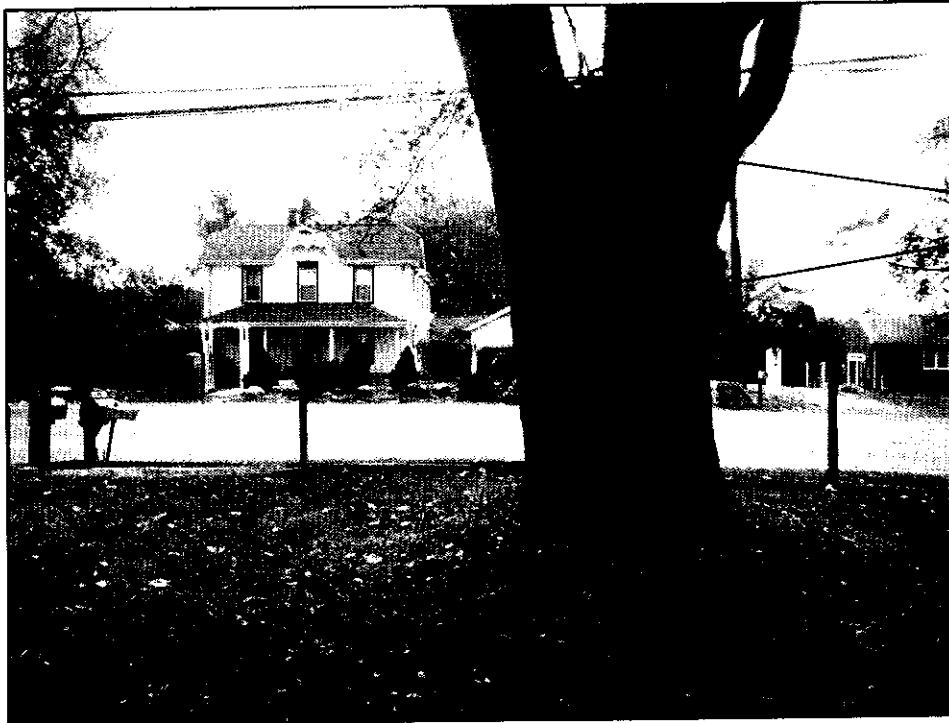
Large  
Vertical  
Split  
(~6' long)

Photo 5. Facing south towards T1 and residence at 13920 Darnestown Road.

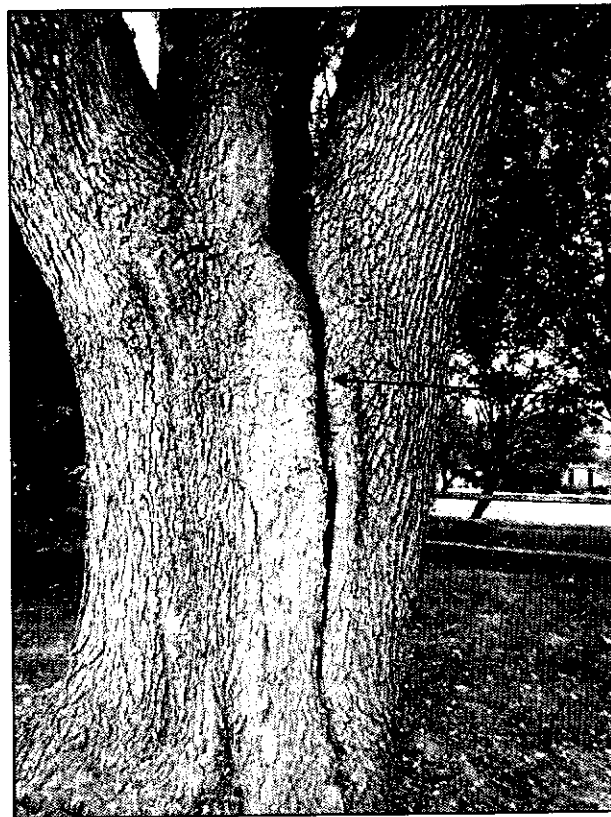
Tree 1 (T1) is a 59" DBH Kentucky Coffeetree (*Gymnocladus dioica*) that is located just west of the driveway at 14001 Darnestown Road. T1 is approximately 95 feet tall, with a crown spread of 96 feet. Lightning protection was observed on the north side of the tree, as shown in the attached photo log. This tree is in poor overall condition and exhibiting crown decline due to age and significant decay in the trunk and co-dominant leaders. **A significant vertical crack (approximately 6' long and 1"-12" wide) has developed in the trunk just below the union of several co-dominant leaders, and the entire eastern portion (right side looking from MD 28) of the tree has split and is shifting toward the driveway and MD 28.** Response growth around the crack is minor. A large column of decay was confirmed in the trunk through visual assessment, probing with a 4' section of rebar, and sounding with a rubber mallet. **It is estimated that approximately 2/3 of the stem diameter is decayed and the decay likely extends into the trunk/root collar union.** Cavities and decay were also observed just above the co-dominant leader unions with the trunk, and on a large lead (16" diameter) hanging over MD 28. **There is significant loading on these defects due to the weight of the mature canopy.**

Large  
Vertical  
Crack  
(~6' long)

Photo 6. Facing north towards large crack at base of T1 where main stem is splitting.

**Tree 1 is recommended for removal due to high overall tree and residual risk to the traveling public and adjacent residents and their properties.** Bracing of the trunk, cabling of the co-dominant leads, crown reduction to reduce loading, and fertilization are possible (\$6,000-\$10,000, with additional costs for monitoring and maintenance), but not recommended for T1 due to extensive trunk decay and declining overall health. Bracing and cabling can negatively affect the load dynamics of large mature trees, resulting in increased loading on the lower trunk and roots. In addition, overall tree health is not likely to improve dramatically with the application of bio-stimulants and/or fertilizer, in conjunction with crown reduction.

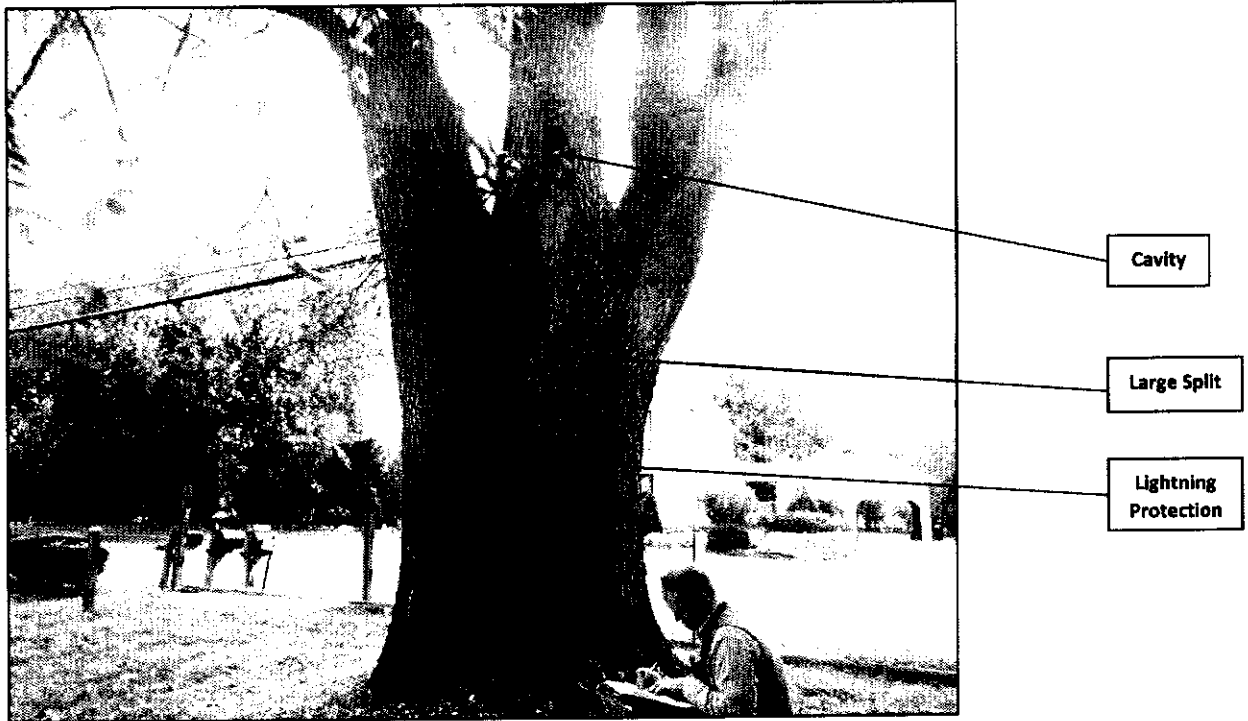
Photo 7. Facing north side of T1 towards cavity, large split, and lightning protection.

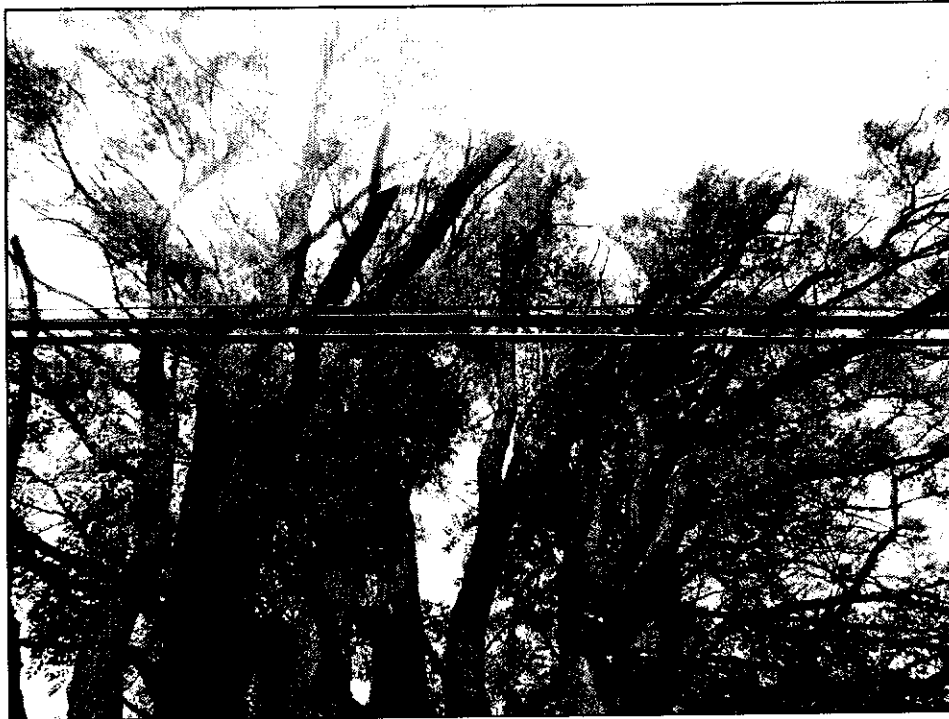
Photo 8. South side of T1 canopy above Darnestown Rd.

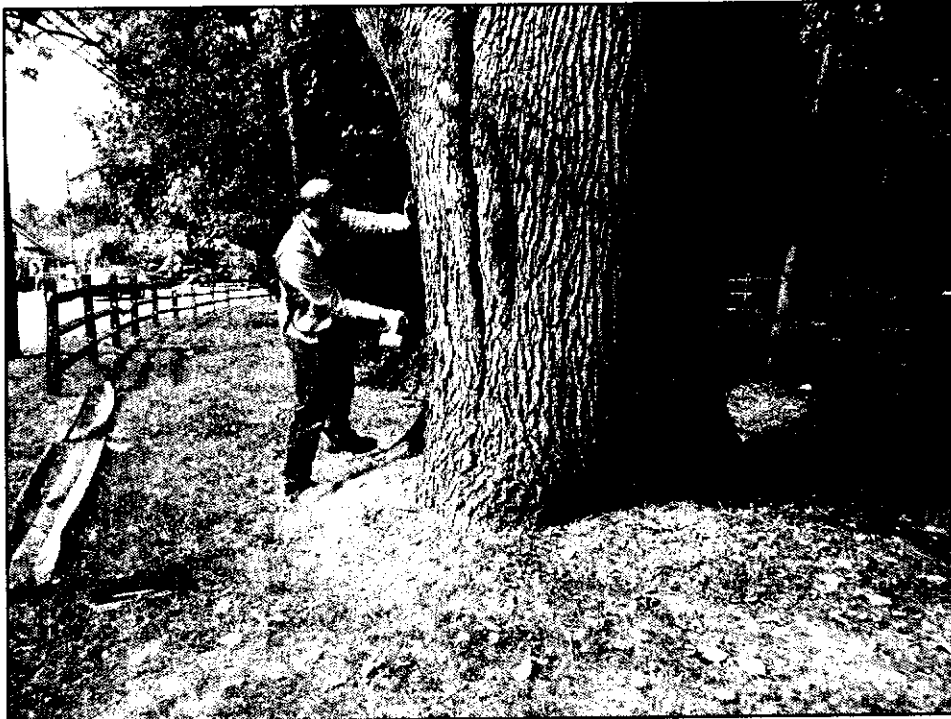
Photo 9. Sounding T1 to determine extent of decay.

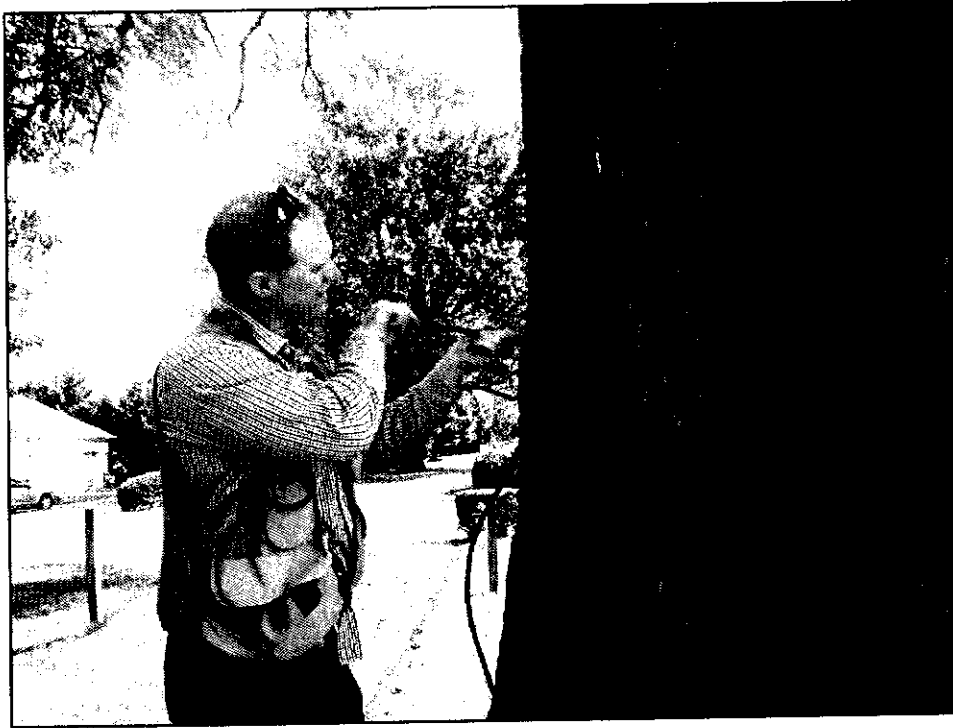
Photo 11. Determining depth of cavity on north side of T1.

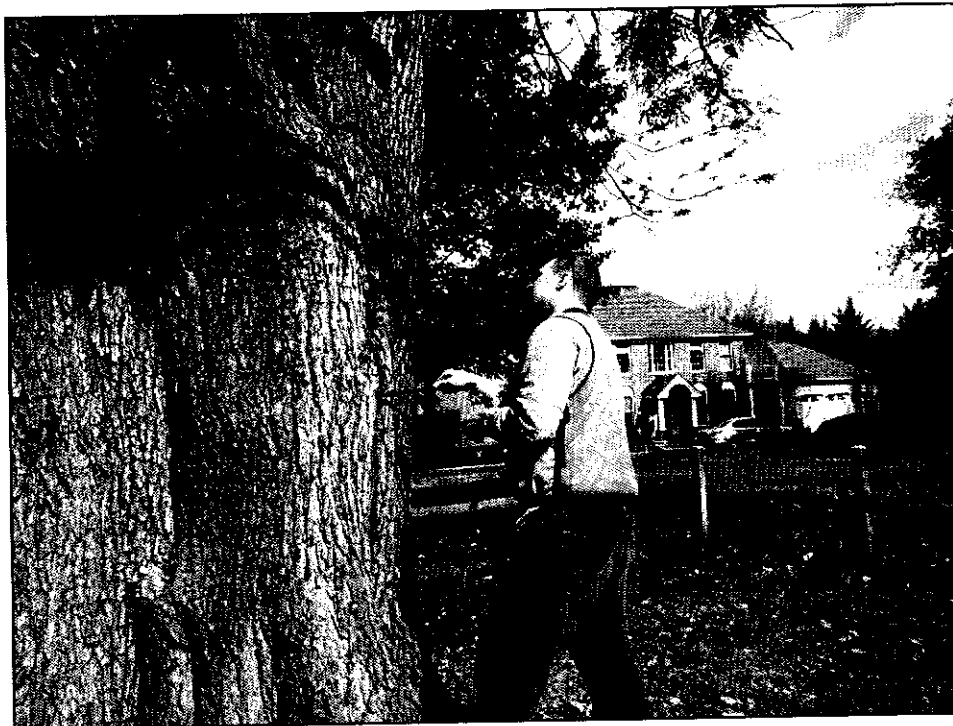
Photo 12. Determining depth of cavity on south side of T1.

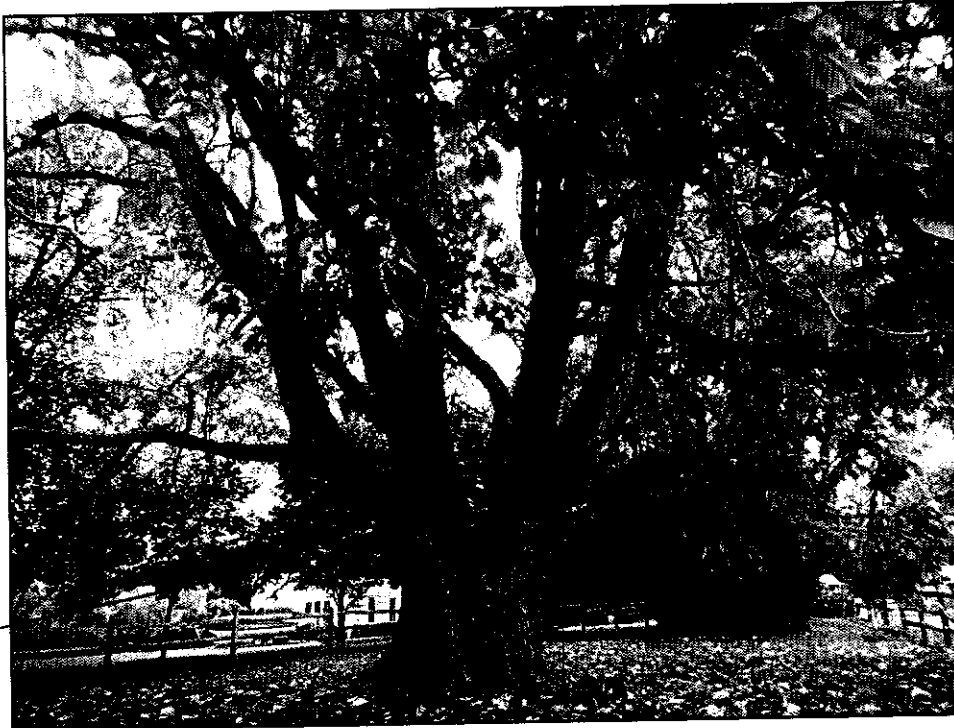
Photo 13. Facing east towards 79" northern catalpa (T2).

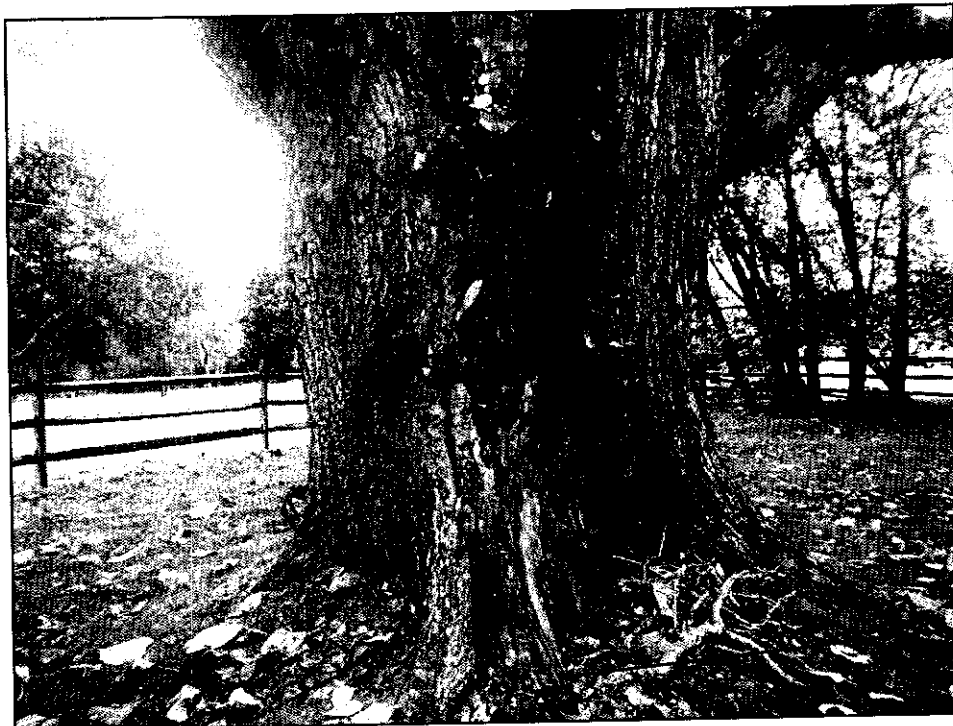
Tree 2 (T2) is a 79" DBH Northern Catalpa (*Catalpa speciosa*) that is located west of T1, directly in front of 14001 Darnestown Rd, and adjacent to Darnestown Heritage Park. T2 is approximately 70 feet tall, with a crown spread of 84 feet. Lightning protection was observed on the east side of the tree, as shown in the attached photo log. **This tree is in very poor condition and is exhibiting major crown decline due to age and significant decay in the trunk and root collar.** Response growth is low, which is another indicator of overall decline in vigor. A major column of decay was confirmed in the trunk through visual assessment, probing with a 4' section of rebar, and sounding with a rubber mallet. **It is estimated that approximately 3/4 of the trunk diameter is decayed and the decay extends into the root collar.** Missing bark, decay, and dieback were also observed in the canopy. Four cables were installed in the canopy by others to provide structural support, but the function of this

Crack  
Associated  
with Large  
Internal  
Cavity

Root  
Flare  
Decay

Photo 14. Facing west towards crack and main stem decay at base of T2.

**Tree 2 is recommended for removal due to high overall tree and residual risk to the traveling public and adjacent residents and their properties.** Remedial activities for whole tree failure are not recommended for Tree 2 due to extensive trunk decay and declining overall health.

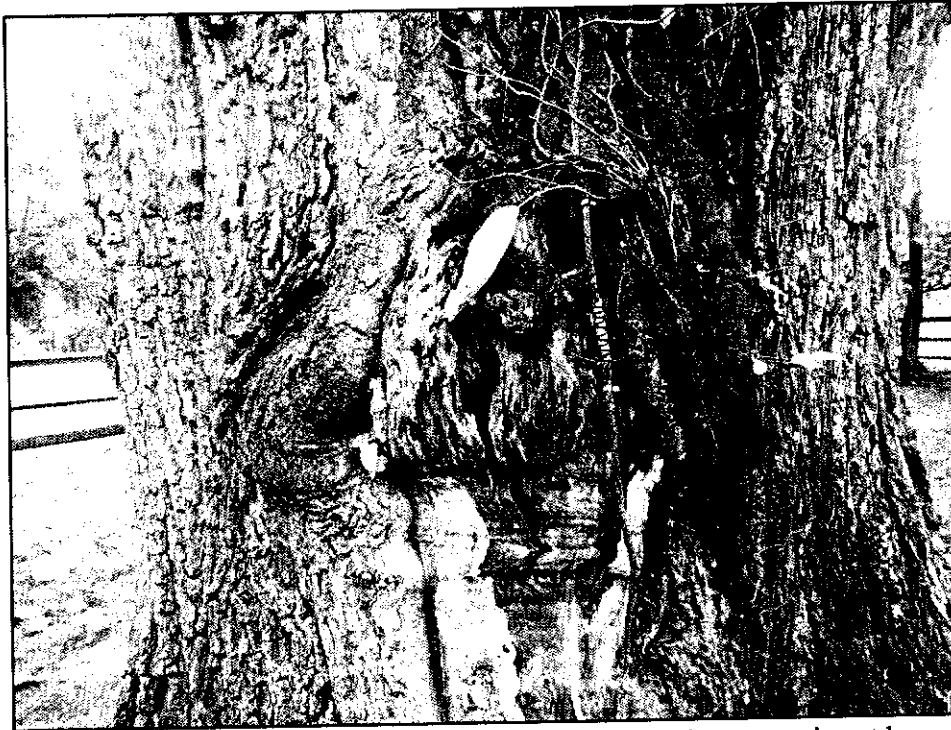
Photo 15. Close up of crack, main stem decay, and lightning protection at base of T2.

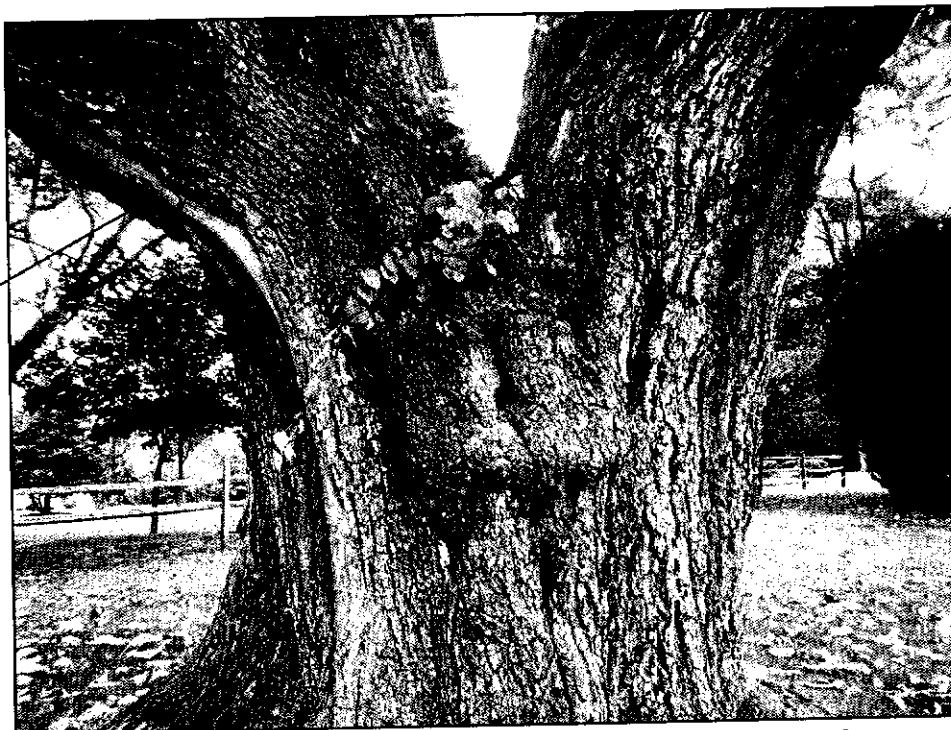
Missing  
Bark/  
Decay

Photo 16. Facing east towards cavities, included and missing bark on T2.

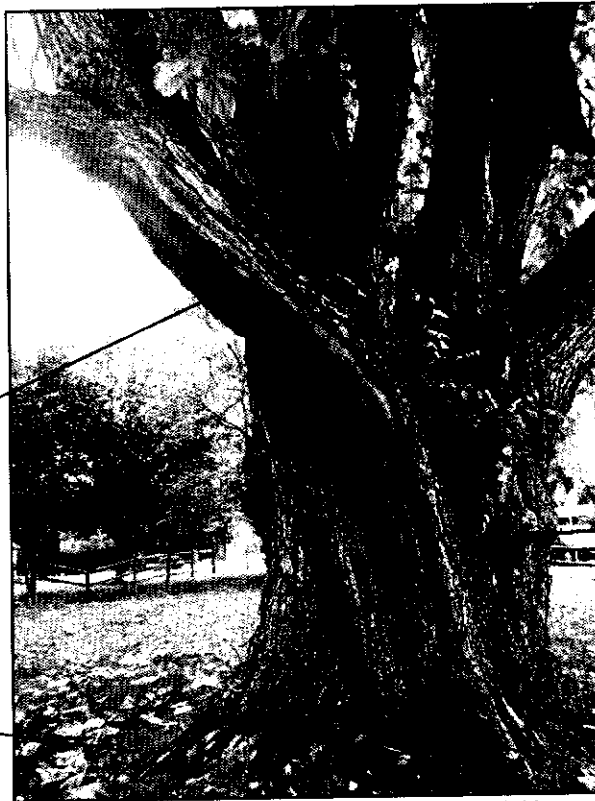
Missing  
Bark/  
Decay on  
Leader

Root  
Flare  
Decay

Photo 17. Facing east towards missing bark/decay on the leader and root flare decay on T2.

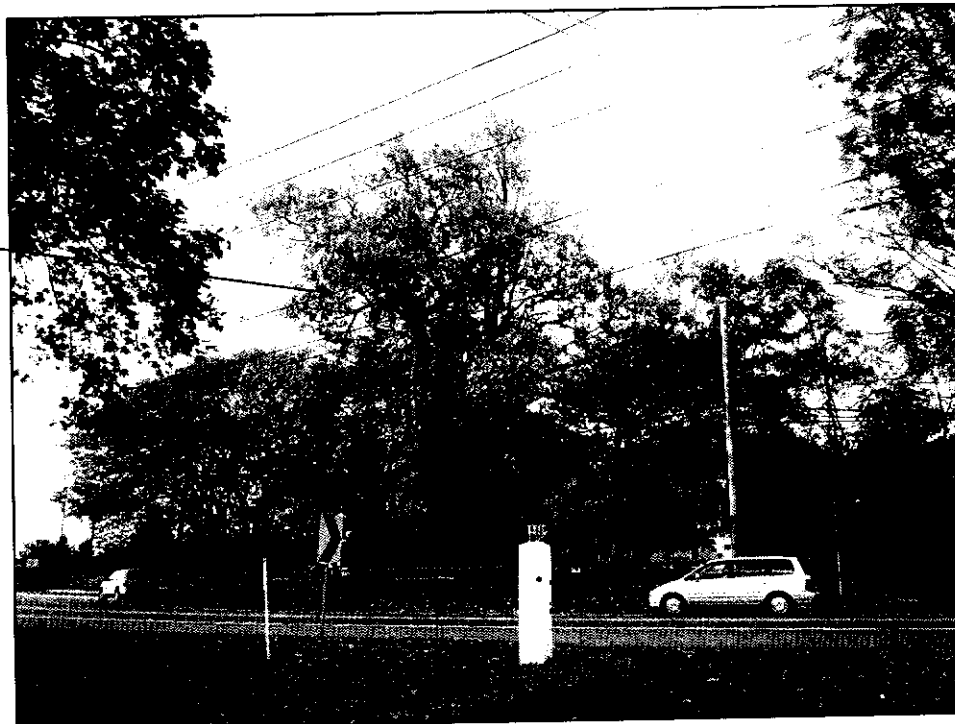
Declining  
Crown

Photo 18. Facing northwest towards crown decline on T2.

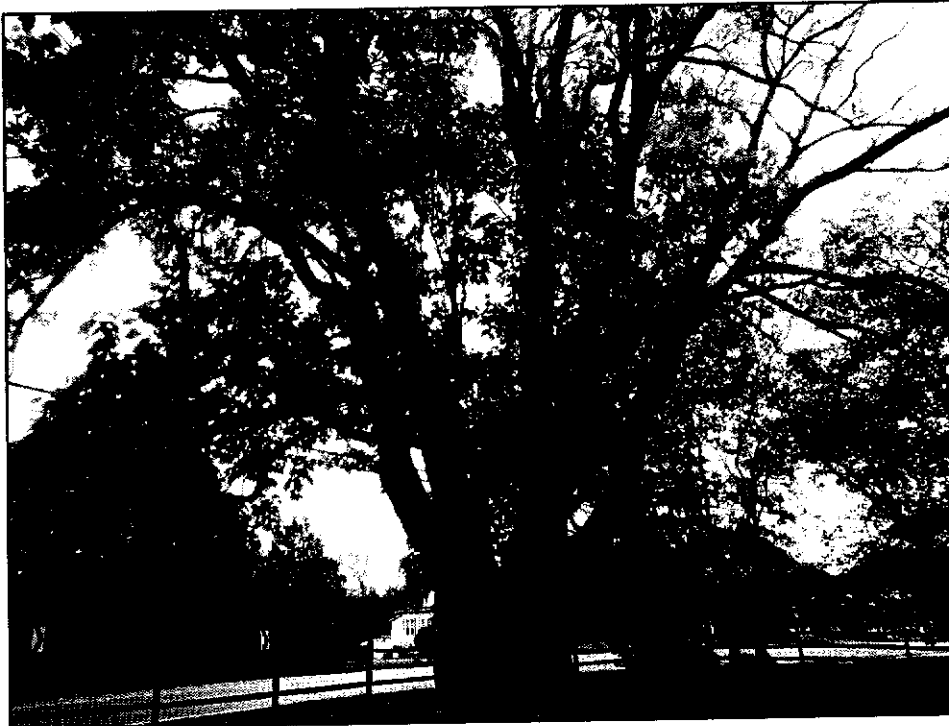
Photo 19. Dieback in the canopy on the east side of T2.

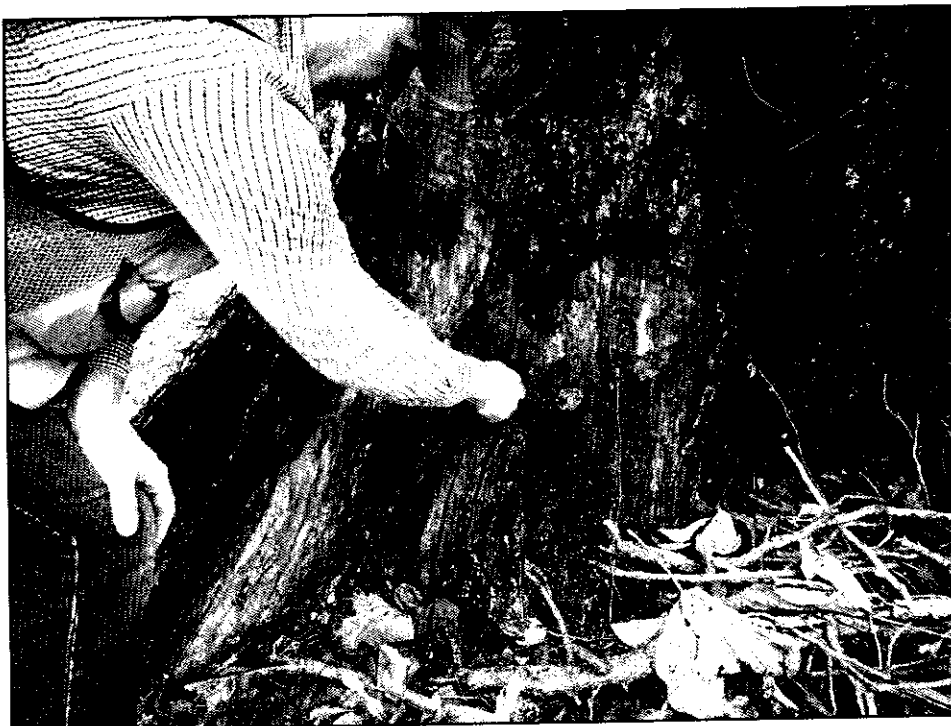
Photo 20. Probing crack at base of T2 to determine depth of cavity inside.

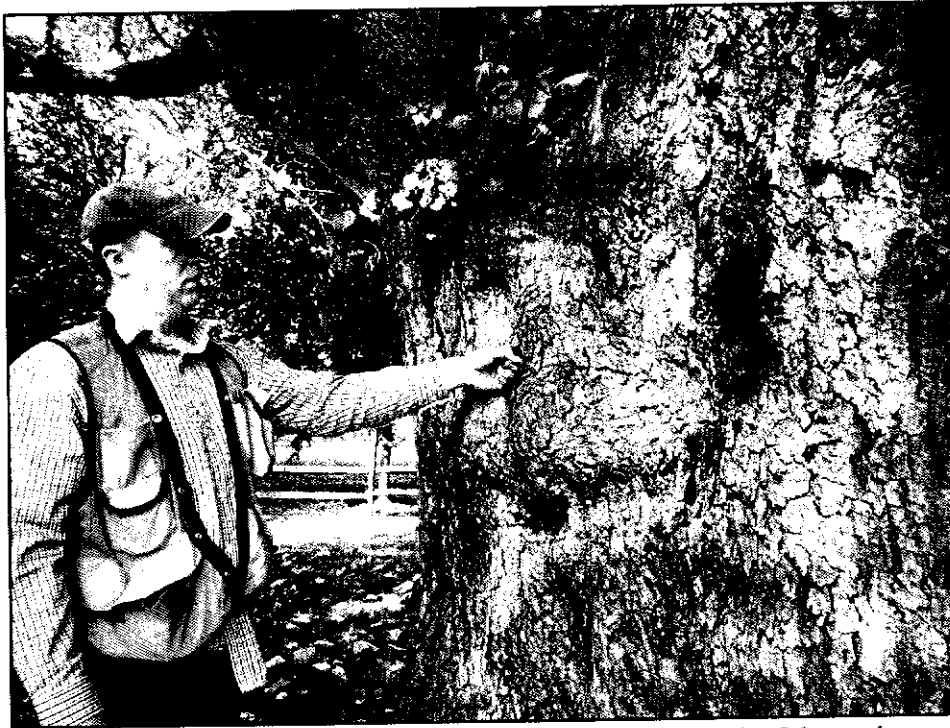
Photo 22. Probing cavity on west side of T2 to determine depth of the cavity.

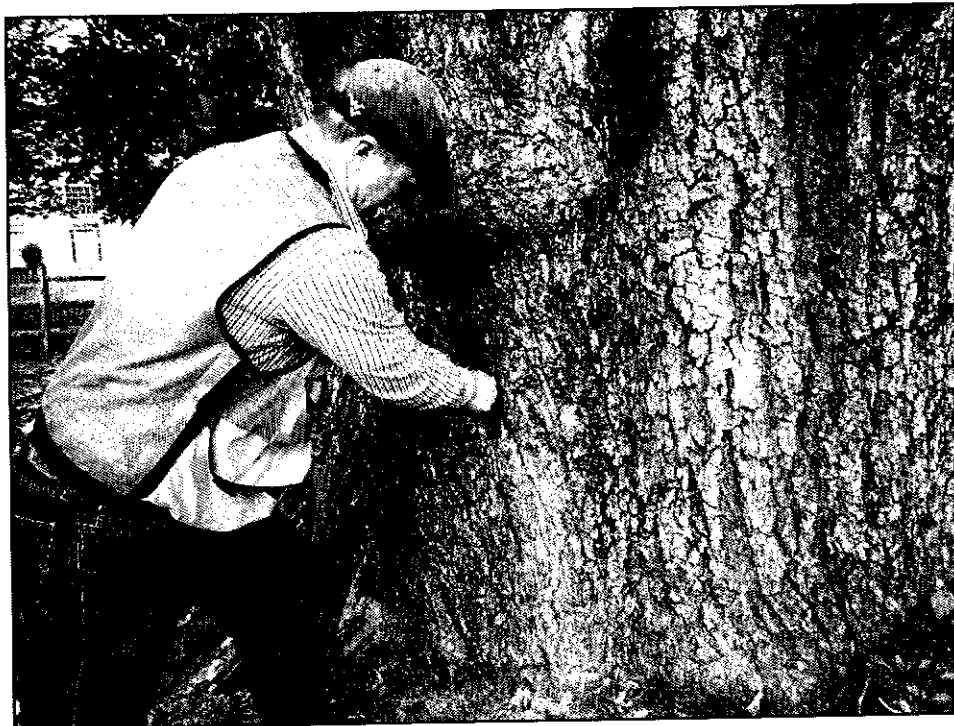
Photo 23. Probing cavity at the base on the west side of T2.

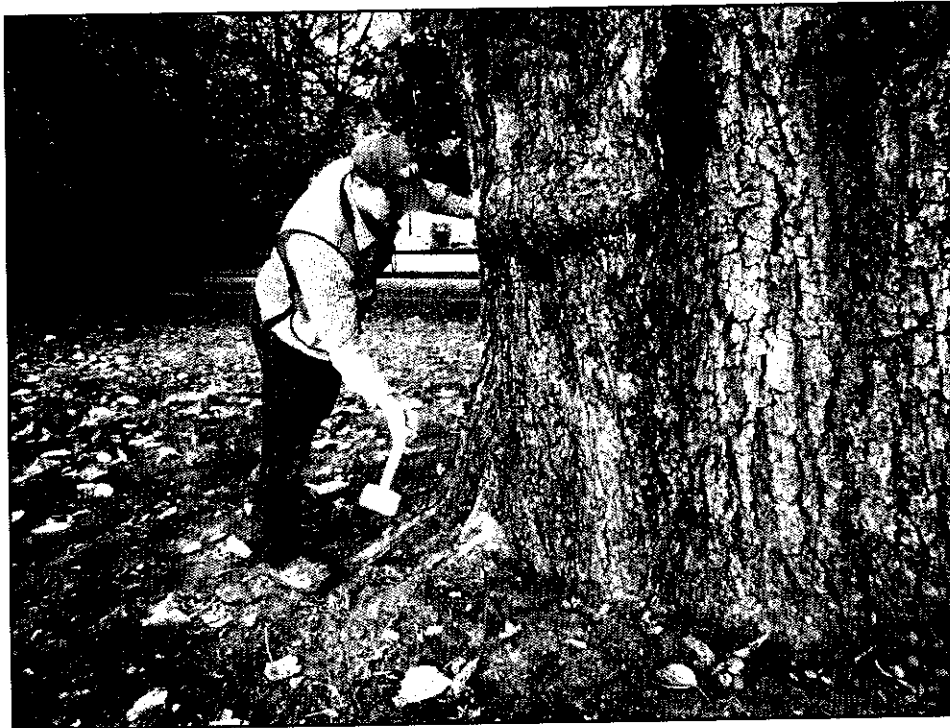
Photo 24. Sounding base of T2 to determine decay/hollow locations.

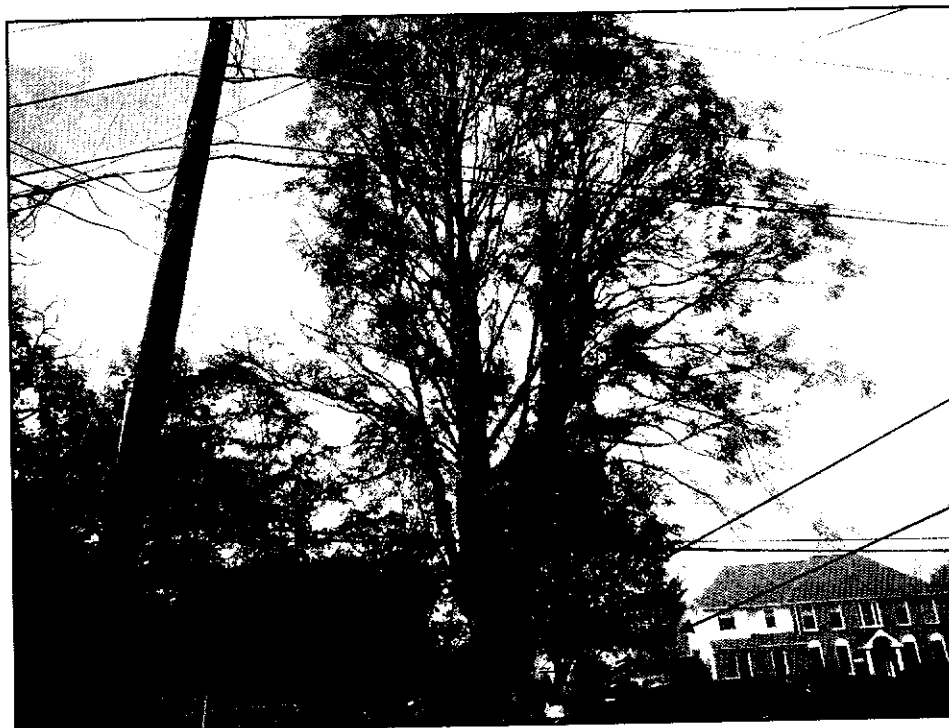
Crack in  
T1

Photo 25. Facing north towards crack in T1 and school bus stop from the residence at 13920 Darnestown Rd.
